Dismantling of the Former Phoenix Glassworks in Konstein (Germany) Contributing to Land Recycling

On the premises of the former Phoenix glassworks, a total of 22 buildings were taken down enclosing an interior space of 62.000 m². The newly established surface was covered with a multi-layer capping system preventing rain water infiltration.

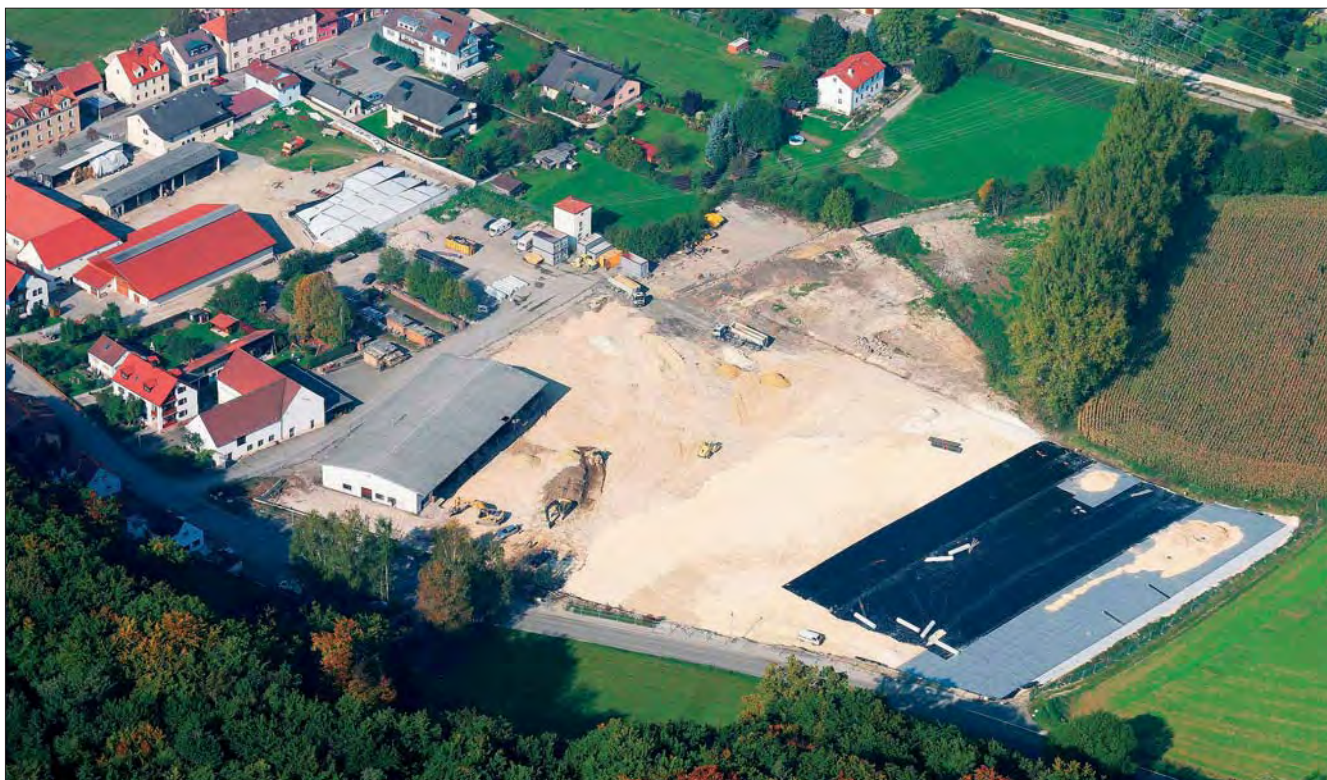
A total of 22 buildings were taken down enclosing an interior space of 62.000 m².

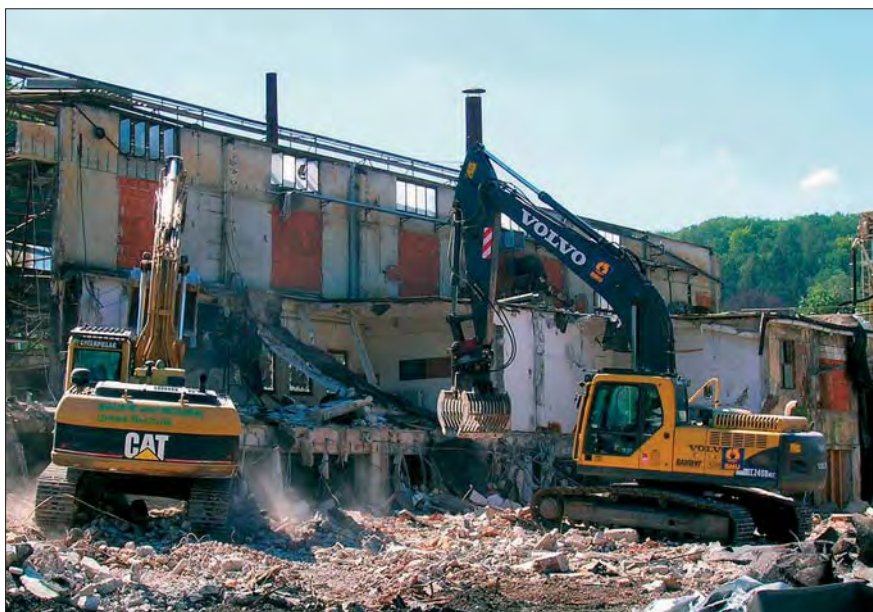
The demolition of the 22 blocks, some of which were as much as 12 metres tall, required the deployment of several excavators simultaneously.

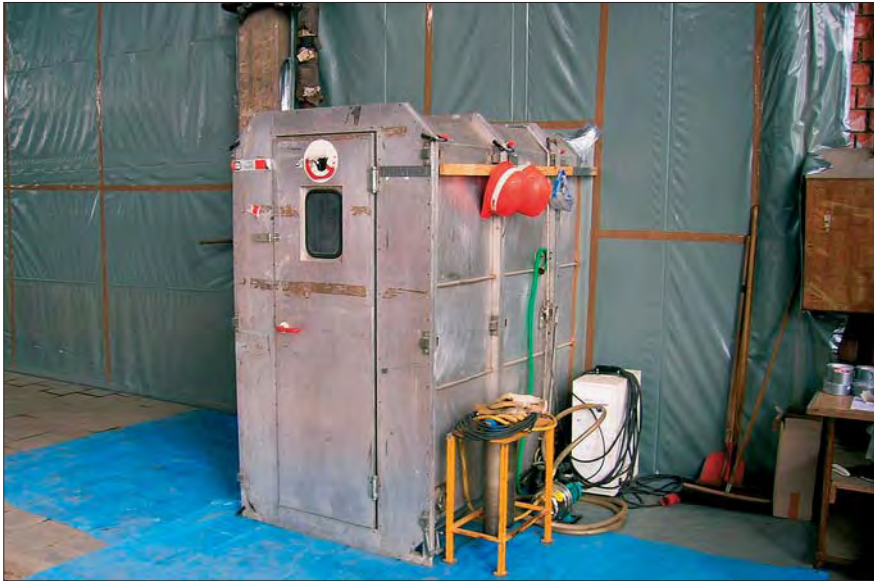
The air in the buildings was contaminated with asbestos, artificial mineral fibres and heavy metals. This required special occupational safety measures. Parts of the buildings were sealed off and made accessible only by way of a three-chamber airlock with a sub-atmospheric pressure system.

BAUER Environment Group began the deconstruction project by decontaminating the 22 production buildings. Owing to the air pollution in the buildings, some

parts of the buildings were sealed off and made accessible only by way of a three-chamber airlock with a sub-atmospheric pressure system. The contaminated air was extracted and purified by a fine-dust filter. The workmen were provided with dust masks and protective clothing.

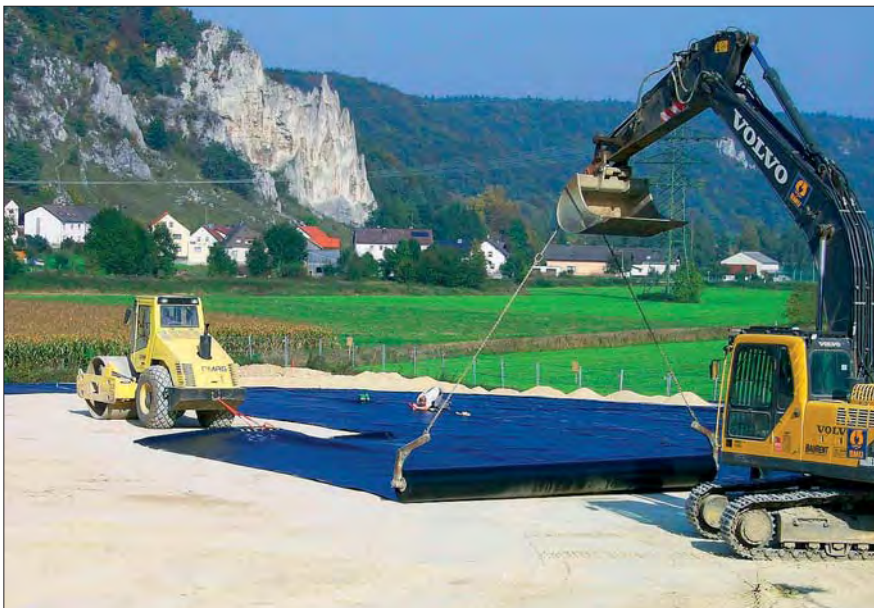
To secure the site against rainwater infiltration, a multi-layer cover system was constructed. Its base is a 2.5 mm thick HDPE sheet, the strips of which were sealed together and the joint then checked for leaks.

To prevent the pollutants remaining in the subsoil from being flushed into the groundwater, the site had to be secured against rainwater infiltration. To that end, a multi-layer cover system was constructed, covering an area of 16,500 square metres. Its layers consisted of:

- a sub-base of broken limestone material
- a protective layer of sand
- an HDPE sheet, 2.5 mm thick
- geotextile drainage elements with filter and separating fleeces
- a frost-proof overburden
- a recultivation layer
