# Remediation of a former Industrial Area in Pottenstein/Germany including Deconstruction and Soil Exchange

**Client:** Pottenstein City Council, Germany

**Scope of Works:** Deconstruction of the Contaminated Built Volumes and Soil Exchange

**Contract Period:** November 2004 until March 2005

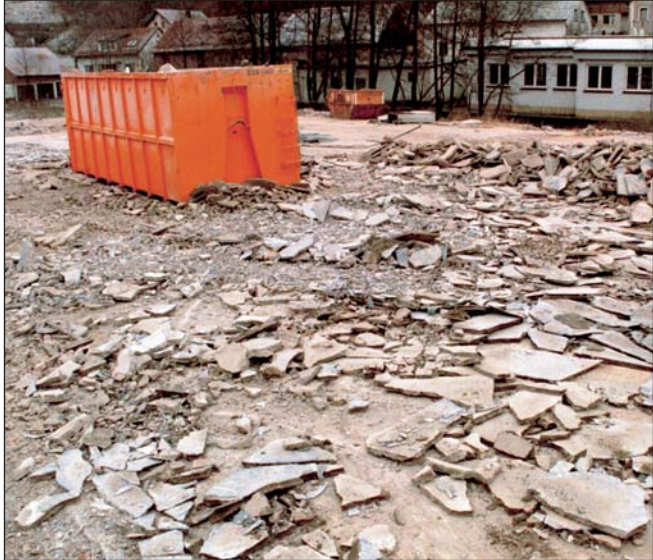
*The screed loaded with petroleum-derived hydrocarbon was removed and the material was dumped on a disposal site afterwards.*

From the base plates of the work areas 1 and 2 the screeds loaded with petroleum-derived hydrocarbon were removed, separated and re-used. The mineral built volumes were broken on site and after an analytic investigation and an appropriate declaration, depending upon lead content, were either used for back filling or dumped on a disposal site. Soil remediation took place at four pollutant bodies on the premises. Two pollutant bodies were remediated by means of excavation sheeting (back embodied carrier sheeting with wooden bracing) and soil exchange up to a depth of 4 m under top ground surface.

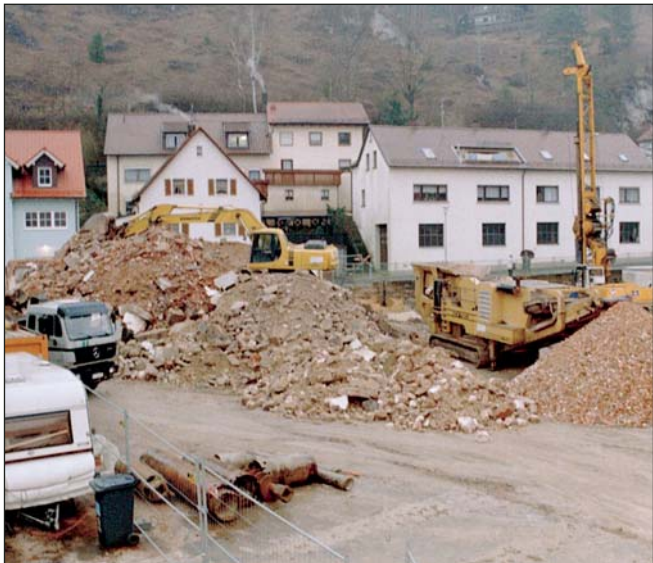
*The mineral built volumes were broken on site and after an analytic investigation and the appropriate declaration, depending upon lead content, were either used for back filling or dumped.*

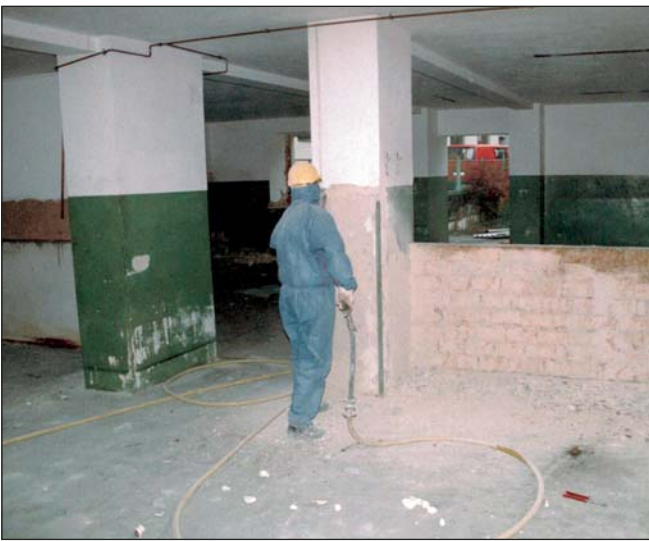
*The existing buildings were cored before the deconstruction and hazardous and contaminated building materials were removed. Altogether 13,800 m<sup>3</sup> were backbuilt.*

The size of the buildings which had to be deconstructed varied from approx. 50 m<sup>2</sup> to 1,500 m<sup>2</sup> floor space. Altogether 13,800 m<sup>3</sup> room were deconstructed. Before the actual demolition took place the buildings were cored and carried back to the structural works.

Pollutant-loaded built volumes e.g. adhesives containing PAH, insulating materials made from artificial mineral fibers, mastic asphalt, wall paint loaded with lead, construction units containing asbestos etc. were dismantled, packed and disposed off separately under strict industrial safety measures. The deconstruction of the extension of a building proved to be extremely difficult, as it adjoined directly to a listed barn and the pertinent bridge over the Puettlach. This area was only accessible by means of an auxiliary construction over the stream.
